Southern Company Transmission

SUPERHYDROPHOBIC COATING FOR POLYMER INSULATORS DEVELOPED BY NEETRAC / GEORGIA TECH

MISSISSIPPI CHEMICAL – MOSS POINT EAST 115 KV T.L.

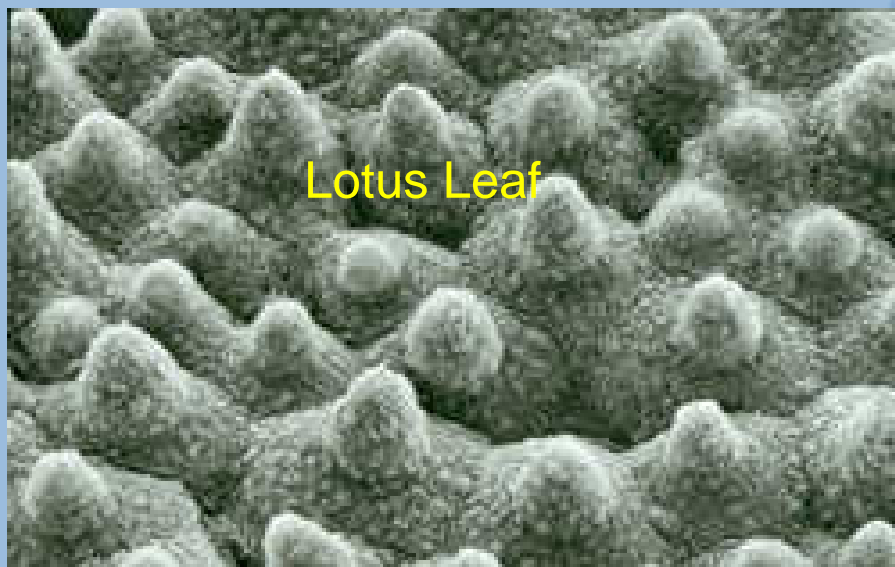
Lotus Leaf

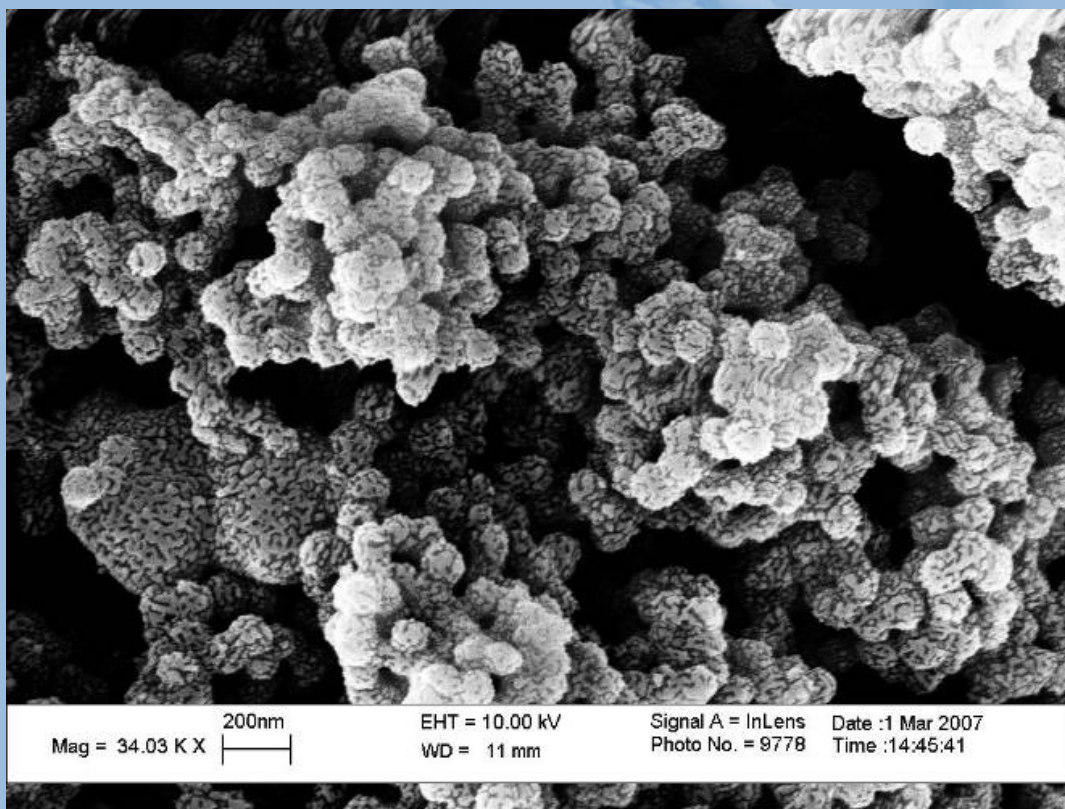
Lotus Effect Surface for Insulators Developed by Georgia Tech / NEETRAC

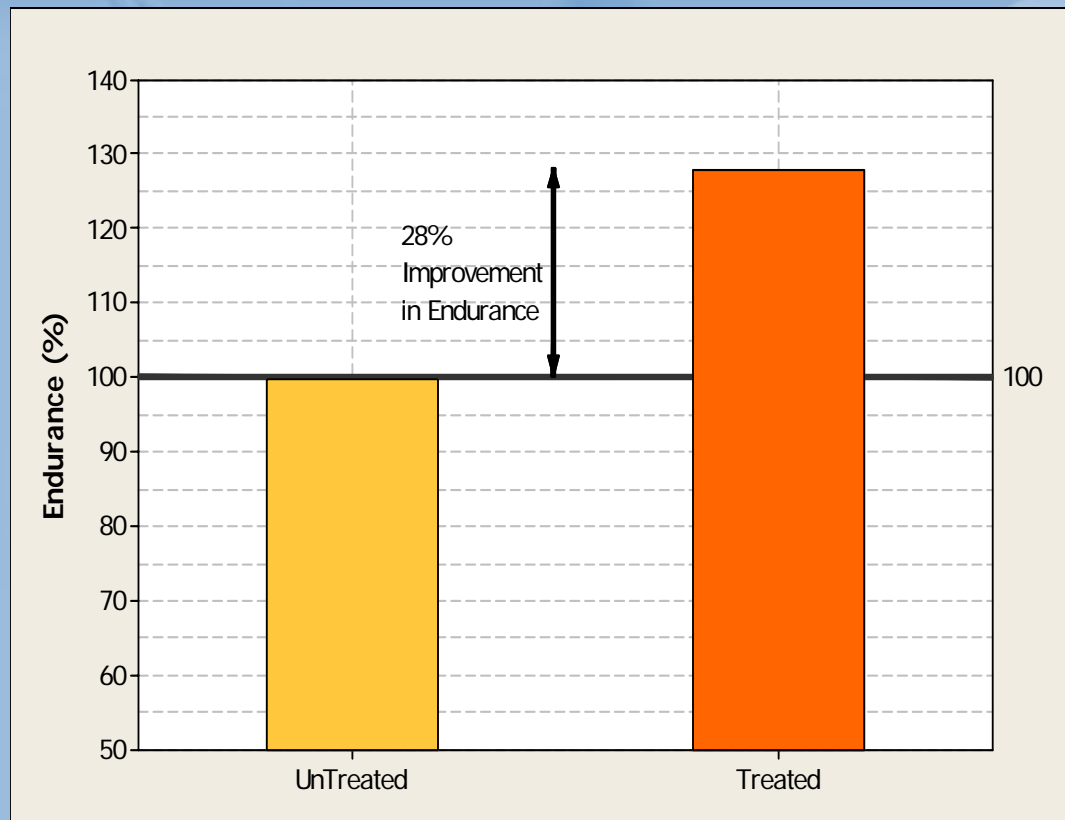
Lab Results

- Works on all polymer insulations
- Lasts at least 2000 hours in energized salt fog testing
- Increases the endurance in accelerated tests

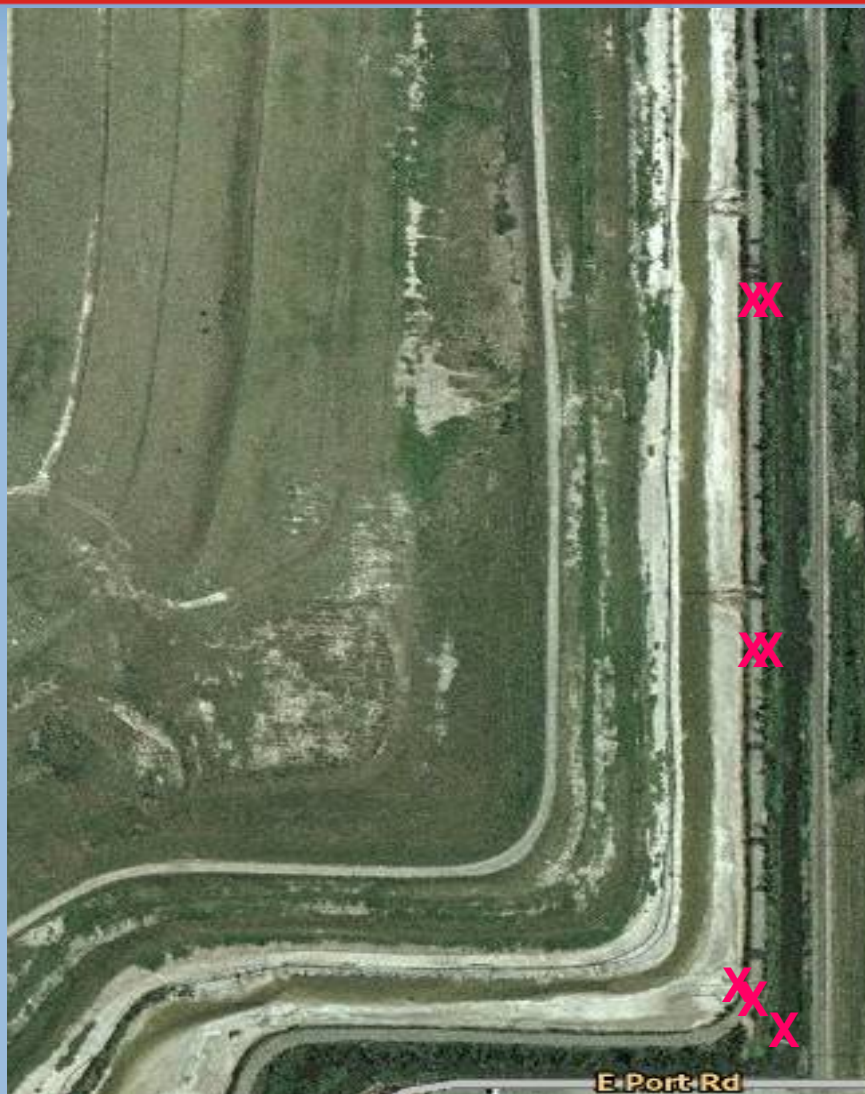
STR#: 54

Wooden H-Frame

STR#: 55

STR#: 56

Wooden 3PDDE

STR# 54

- Replaced three Suspension Insulators installed in 2005 with three new Polymer Suspension Insulators.
- Insulators were new and NOT Coated with the new solution.

STR #55

- Replaced three Suspension Insulators installed in 2005 with three new Polymer Suspension Insulators.
- Insulators were treated with the new coating solution.

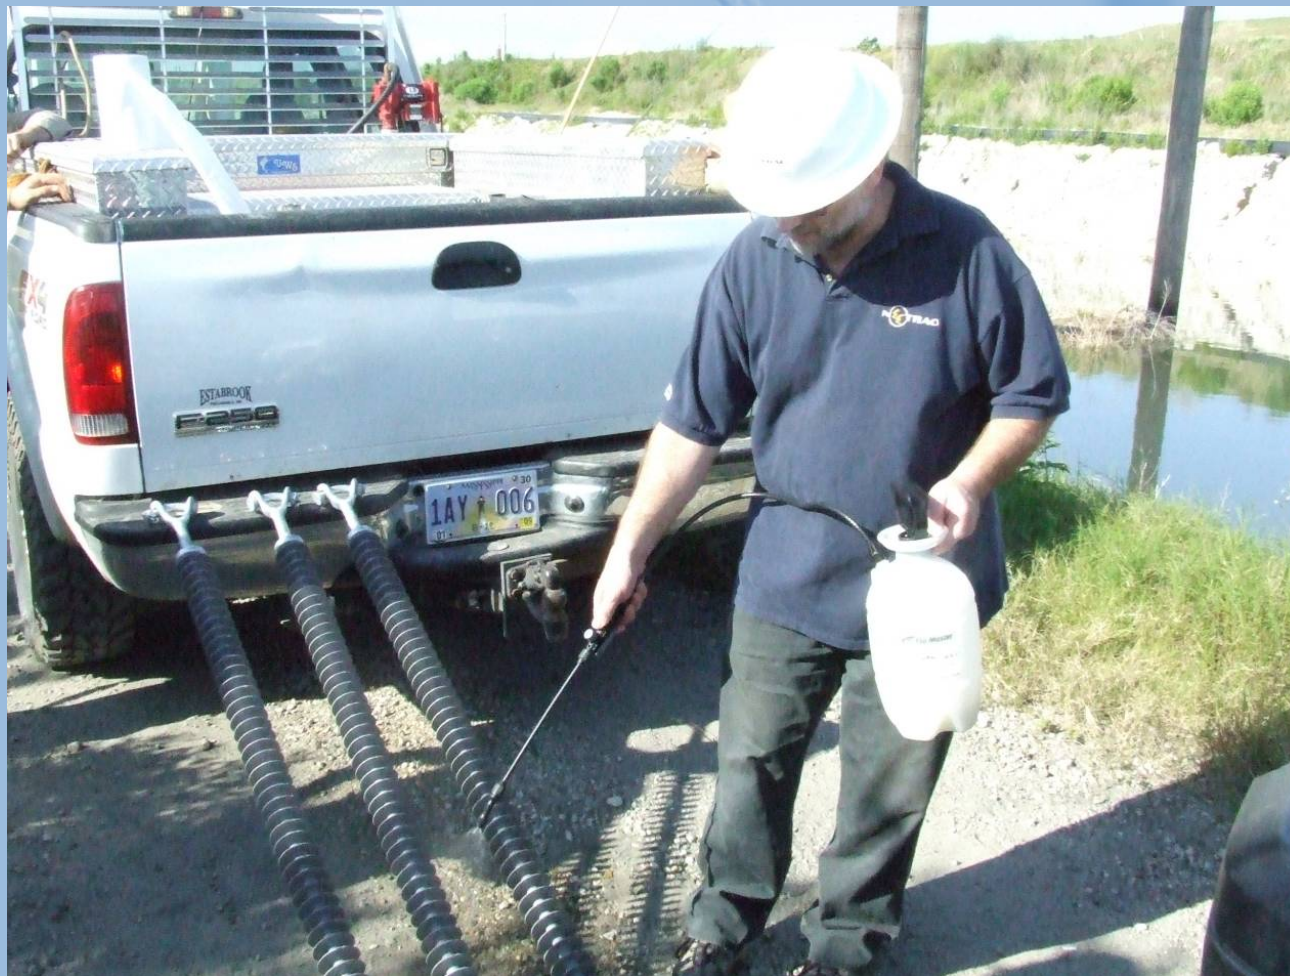
Superhydrophobic solution applied to the new Quadri*sil™ Insulators

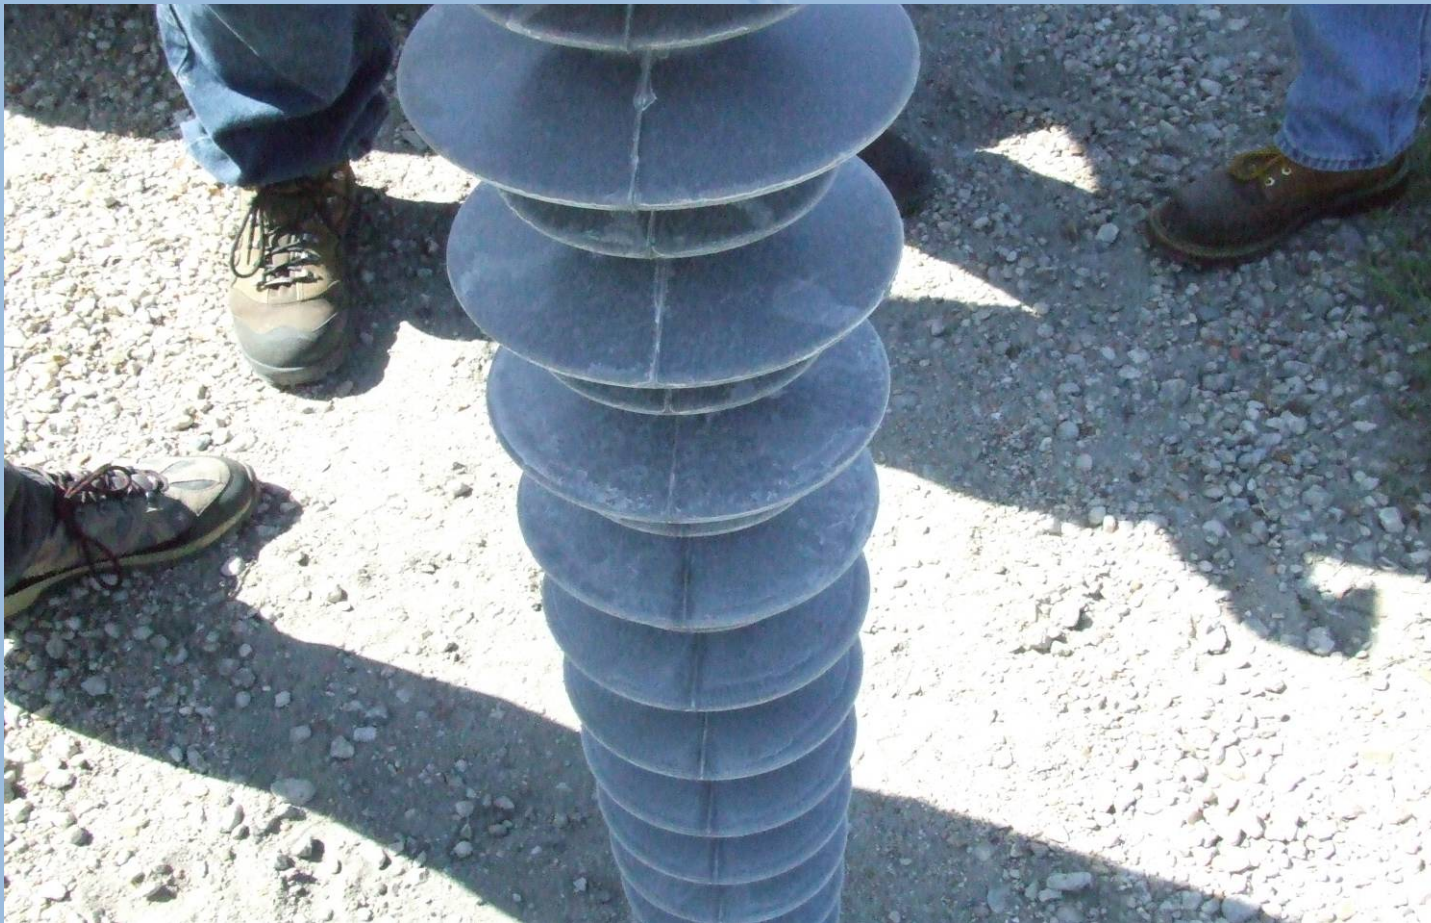
Superhydrophobic solution on new Quadri*sil™ Insulator

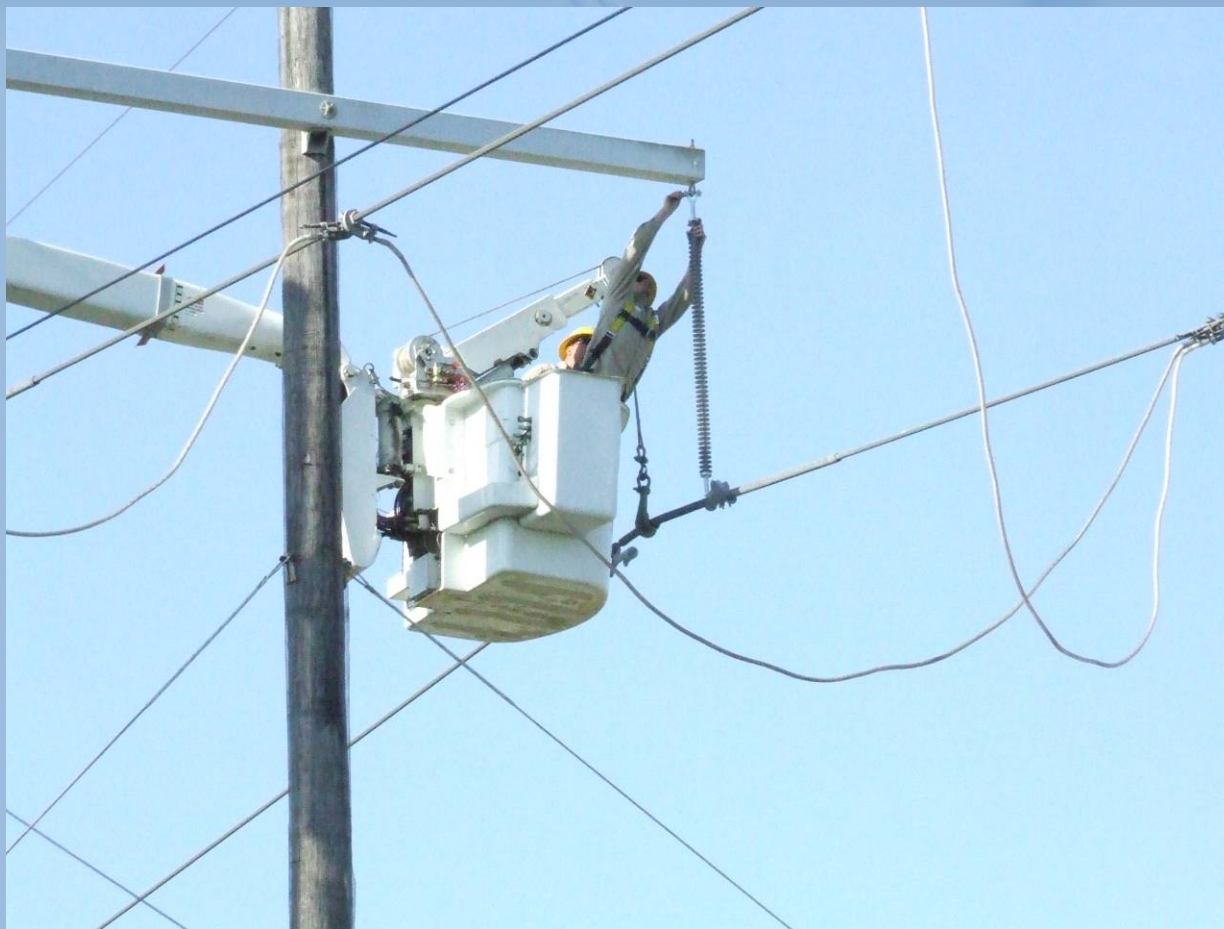
Installing new uncoated Insulator at Str.# 54

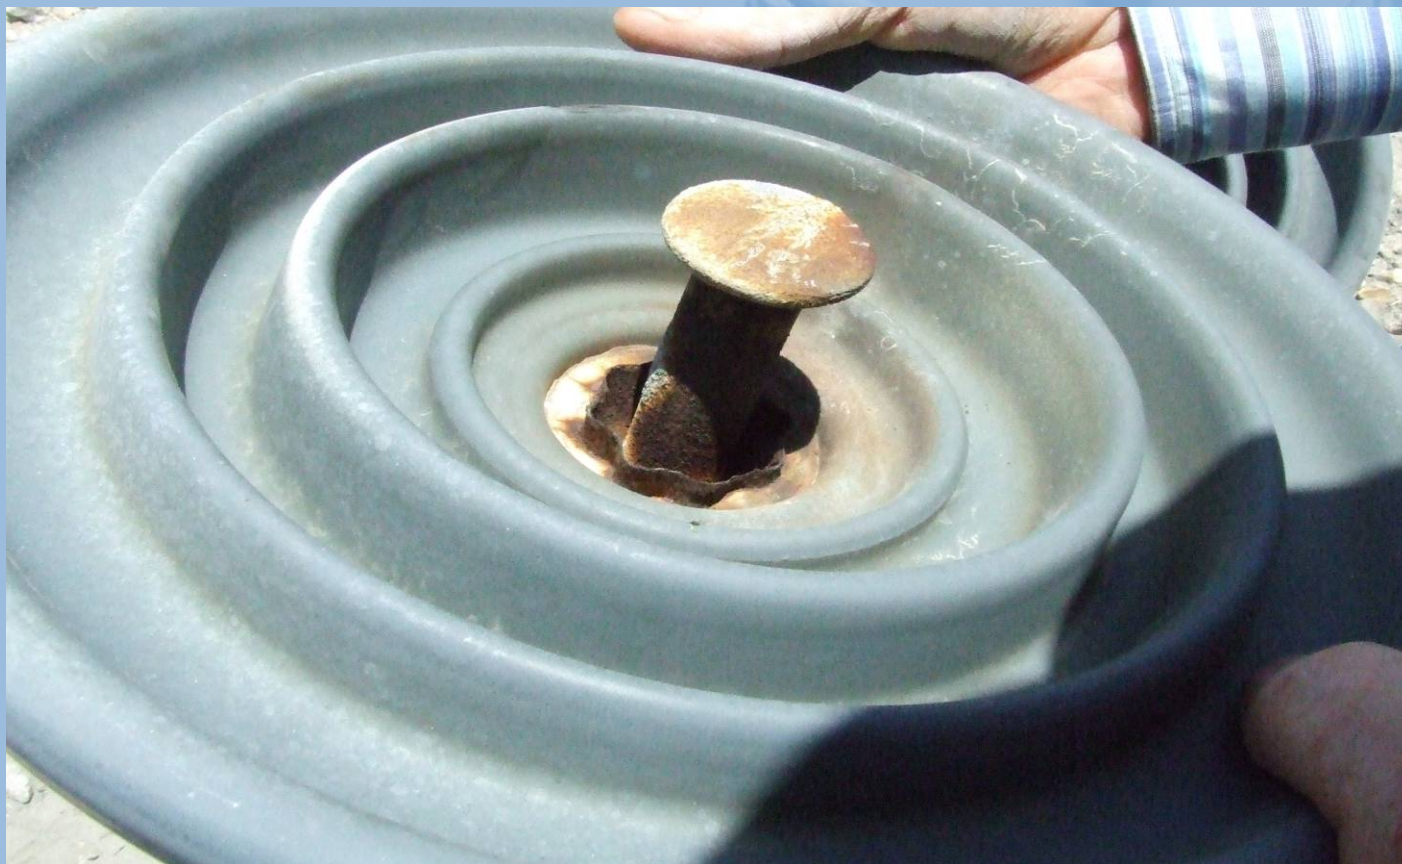
Severe Pin Corrosion was found on all of the Porcelain Insulators which were removed. These insulators had been in service approximately three years.

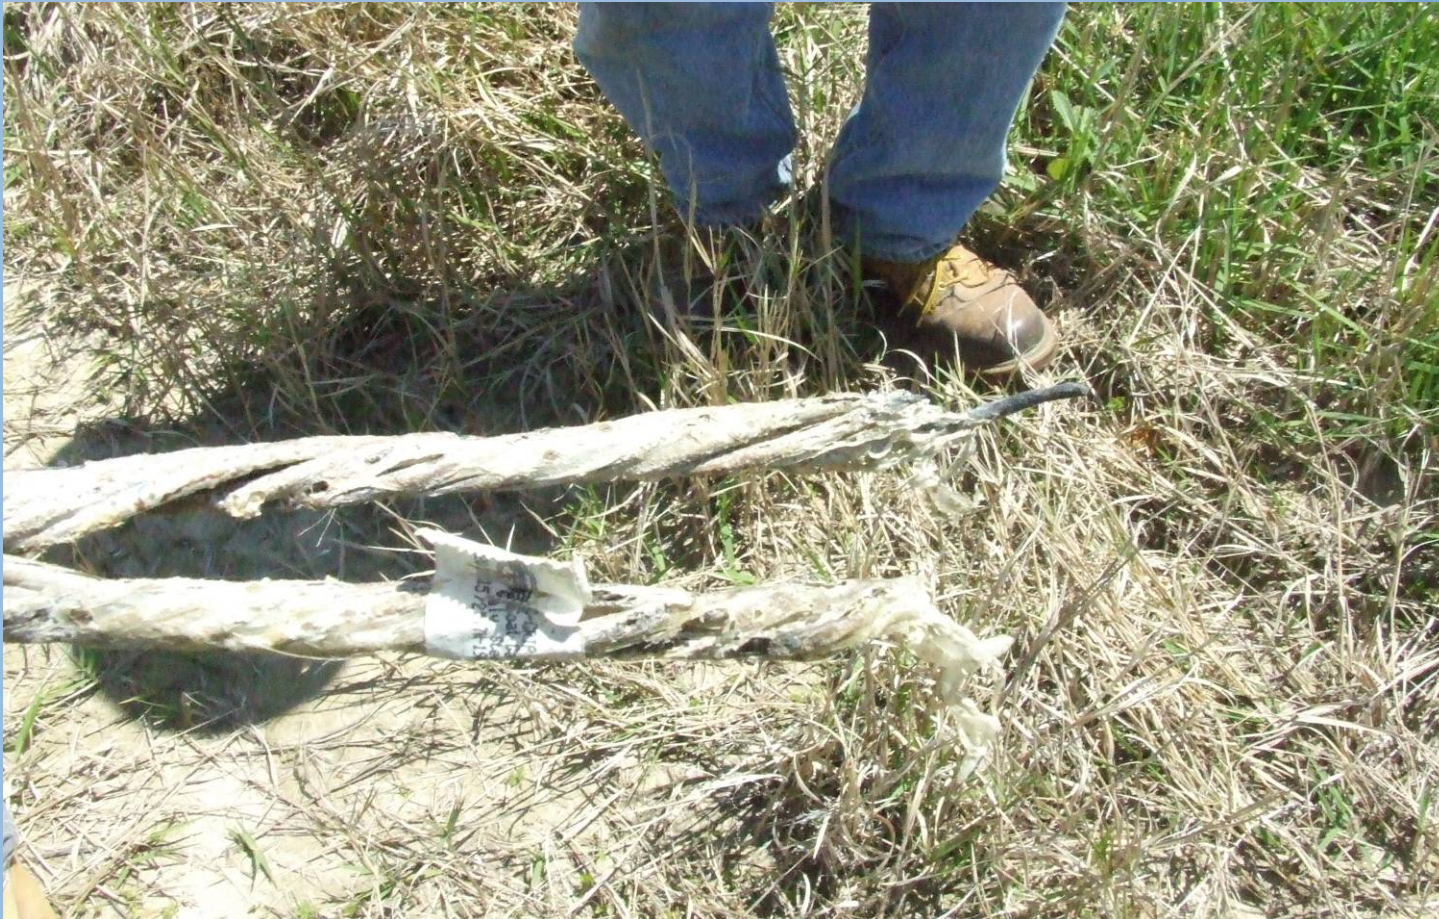
This guy grip had been in service for six weeks. Notice that the loop that wraps around the anchor attachment point has corroded out of the guy grip.

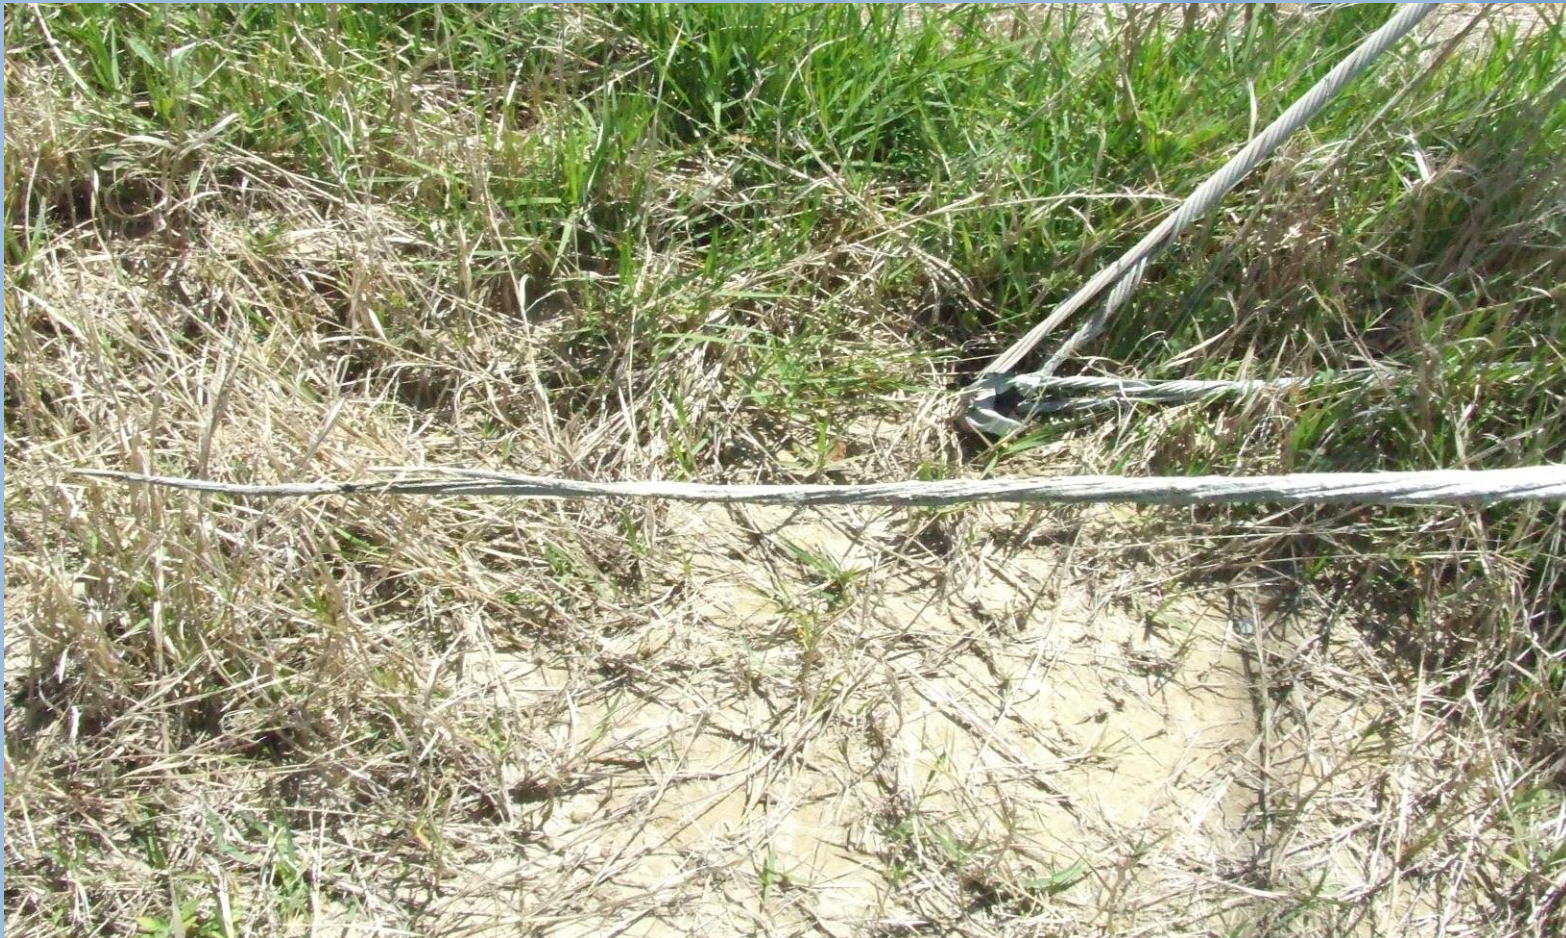
This guy wire had been in service for six weeks. Notice that the individual strands have necked down much like you would expect to see from a tensile failure.
